Technical Memo

Project Name: Campus Hot Spot Assessment

Client: St. John's University

Re: Summary of Findings

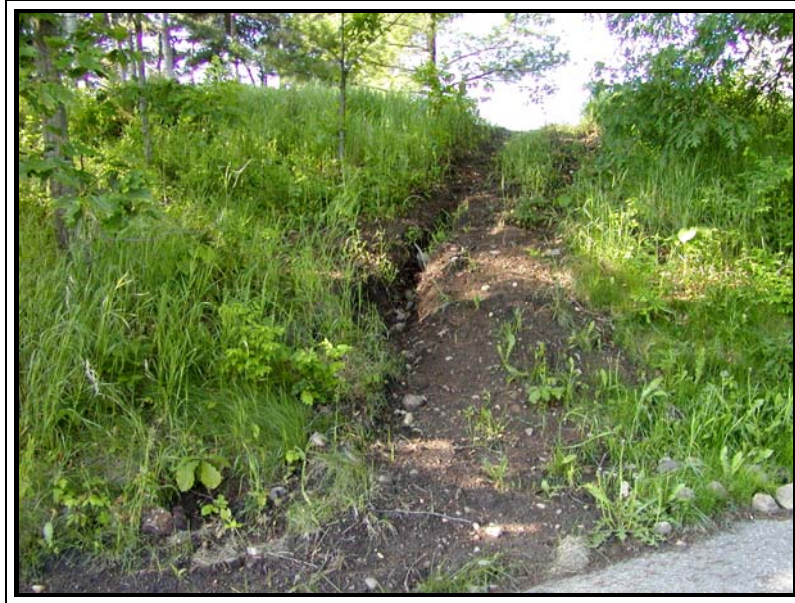
Figure 1 – Unstable slope behind tennis court

At the time of the field visit, several construction activities were underway creating disturbed soils. As well, various areas of the campus were observed to have exposed and unstable soils in the form of rills. Most of these were small and localized thus were not directly accounted for in the P-8 model. The exception to this is the coal storage area at the power plant, which was accounted for in the P-8 model.

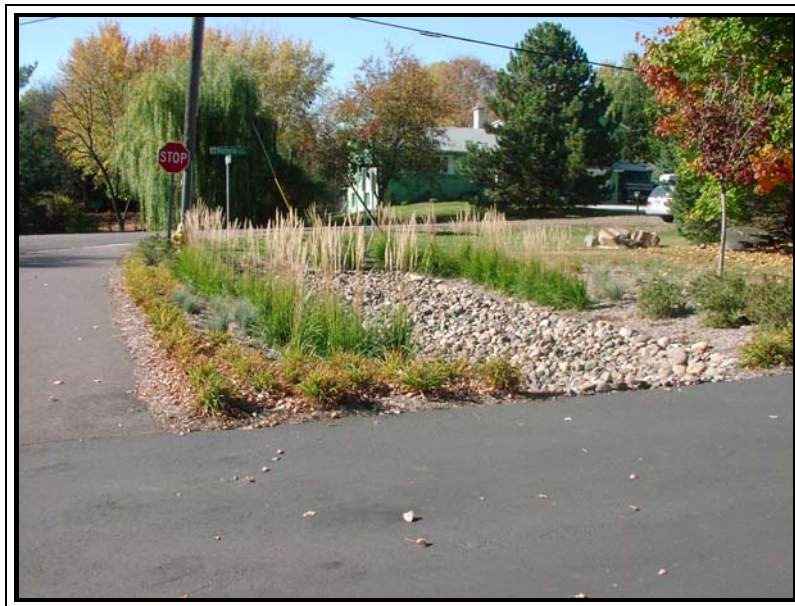
Figure 2 – Illustration of a roadside rainwater garden

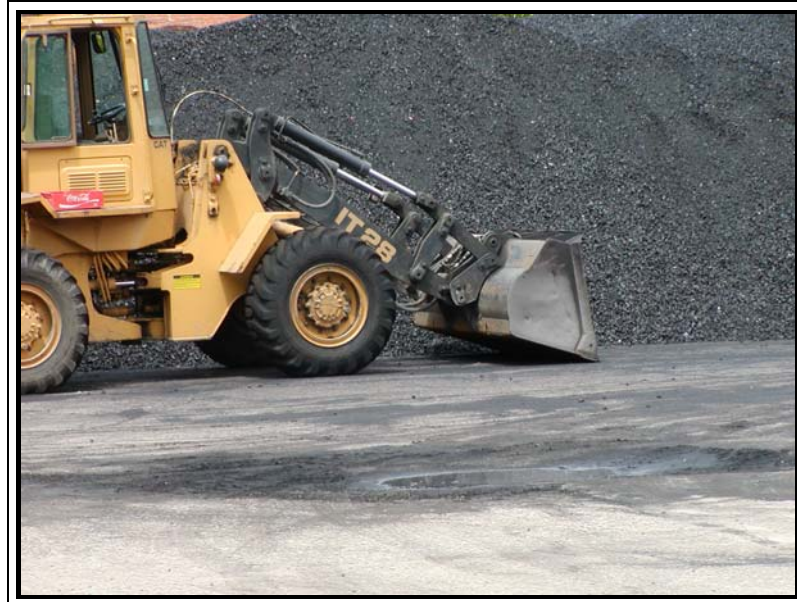
This area is highly influenced by the coal storage practices at the power plant (Figure 3). It also has a substantial amount of impervious area (64%). Particulates and TSS are the key pollutants of concern in this area. Several opportunities exist to address this hot spot.

Figure 3 – Clogged catch basin at power plant

1. Construct a covered facility for coal storage and handling.
2. Install a structural treatment device such as a swirl concentrator unit.
3. Retrofit the parking lot adjacent to the Liturgical Press to provide a vegetated filter strip, treating the overland discharge of pipe flow at this location.

Retrofit the existing drop manhole on the west side of County Road 159 with a swirl concentrator unit. Preliminary calculations were made assuming this recommendation would be implemented with a V2B1-type swirl concentrator (model 4) which is sized to handle a peak runoff flow of up to 4.3 cfs. This would accommodate peak runoff from storms over 1.0 inch (almost up to 1.5 inches). If this recommendation is implemented, moving directly into system design would be an appropriate next step.

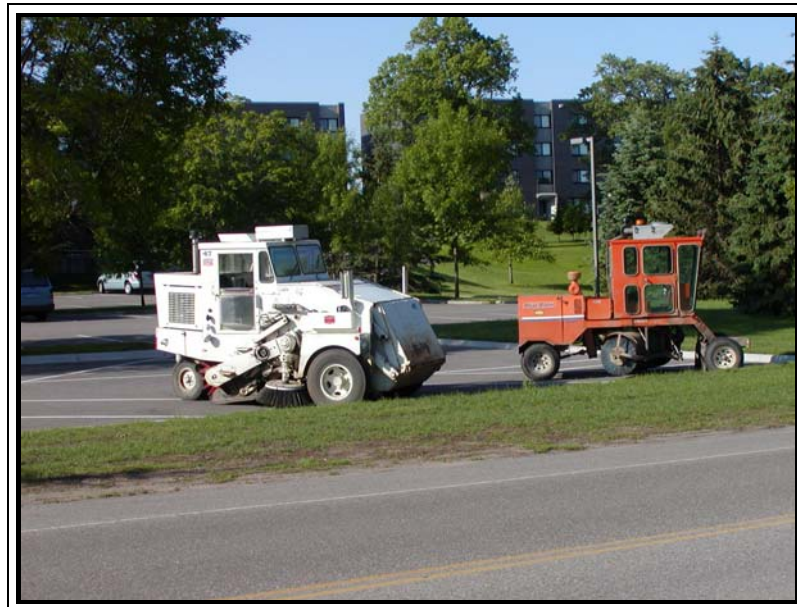
Figure 4 – Street and parking lot sweeping is critical

The recommendation for this area is to employ good housekeeping efforts within the drainage area itself. For example, it would be beneficial to maintain the roadways and paths here on a more vigorous level by means of sweeping. Another option for future consideration might be procuring and installing catch basin filtration devices at key junctions within ST3 to treat stormwater runoff as it enters the conveyance system. Inspection of the device is typically performed quarterly, with maintenance being performed as needed. Vacuuming of accumulated sediment and debris is followed by evaluation/replacement of the filter media. A common alternative to this filtration device is to utilize manholes that have a sump feature. However, in this case, any existing manholes would need to be entirely removed and replaced with a new manhole and sump.
